Manhole Inspection Summary

Manhole # S25I__038MH

Insp Date: **3/14/08 1:21 PM**

Location Address: **1143 HOLLINS ST.**

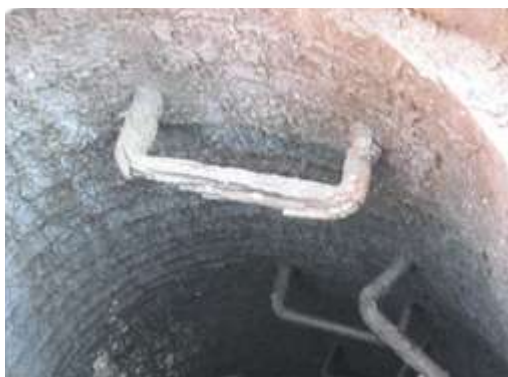
Defect 4

Count: **5** Missing: **0** ☒ **Corroded**

CORRODED STEP

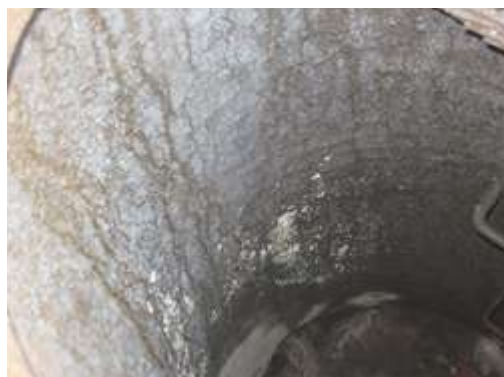
Defect 3

Infiltration: ☐ None ☐ Joint ☐ Cracks ☐ Mortar ☐ Roots ☒ **Wall**

EVIDENCE OF INFILTRATION FROM
CHIMNEY TO BARREL

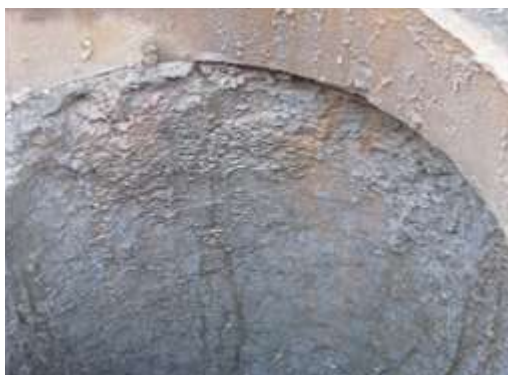
Defect 2

Condition: ☐ Sound ☒ **Cracked** ☐ Root Intrusion ☐ Loose Brick ☐ Deteriorated

Infiltration: ☐ None ☐ Joint ☐ Cracks ☒ **Mortar** ☐ Roots ☐ Wall

EVIDENCE OF INFILTRATION AT THE
CHIMNEY MISSING MORTAR

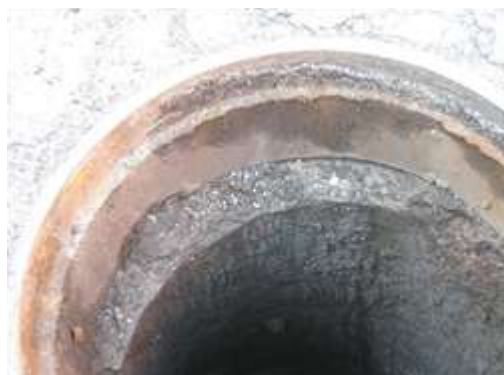
Defect 1

Offset: **3** (in.)

3 IN FRAME OFFSET

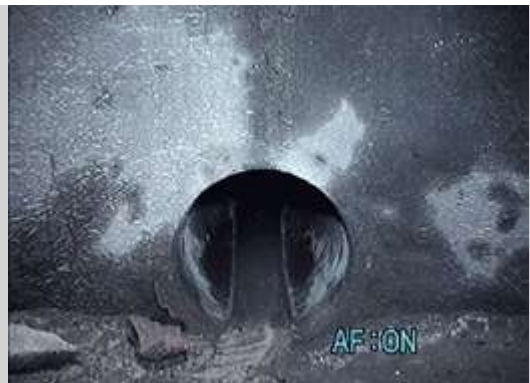
12 O'Clock Outflow

8 in. Circular Gravity Sewer
Pipe Out @ 12 O'Clock

Pipe Height: **8.4** (in.) Rod and Bar (Angled)

Pipe Material: **Clay** ☐ Pipe Lined

Invert Depth: **9.10** (ft.) Flow Characteristics: **None**

Infiltration: **None** Pipe Seal Cond: **Sound**
